DESCRIPTIVE REPORT

Type of Survey Wire Drag

Locality Approaches to Mobile Bay

H-9420 WD FE-276 WD

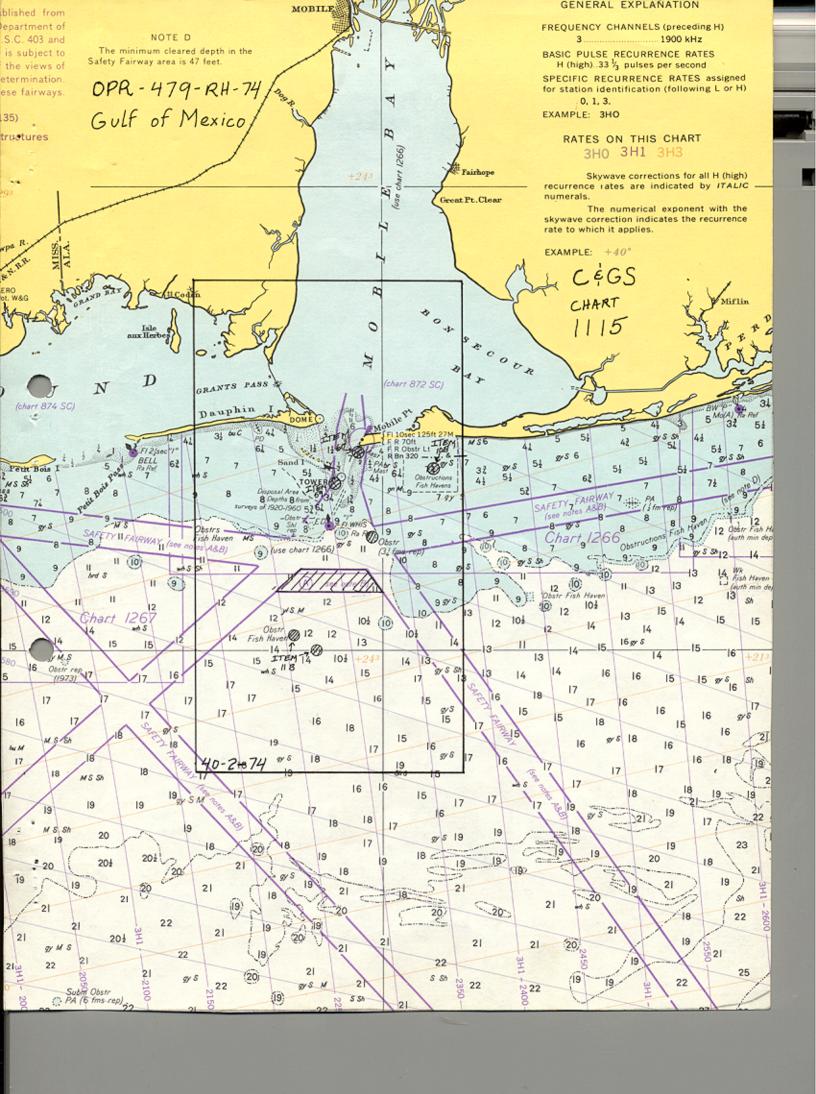
Q Falco Perdido ALABAMA FLORIDA Munson Gateswood MOBILE BAY BON SECOUR LITTLE PT. CLEAR Diagram H-9374△ INDEX HYDROGRAPHIC SURVEYS HYDROGRAPHIC SURVEYS Date 1970 1973 Scale 20.000 40.000 No. H-9109 H-9374∆ Complete through August 1978 30°00 1970-1973 On Scales of 1:10000 6.34 inches=1 statute mile 1:20000 3.17 inches=1 statute mile CHOCTAWHATCHEE BAY - MOBILE BAY No. △-Wire drag FLORIDA-ALABAMA 85
